CENTRAL MINE METHODIST EPISCOPAL CHURCH
Main East-West Road
Central
Keweenaw County
Michigan

WRITTEN HISTORICAL AND DESCRIPTIVE DATA

HISTORIC AMERICAN BUILDINGS SURVEY

HABS No. MI-421

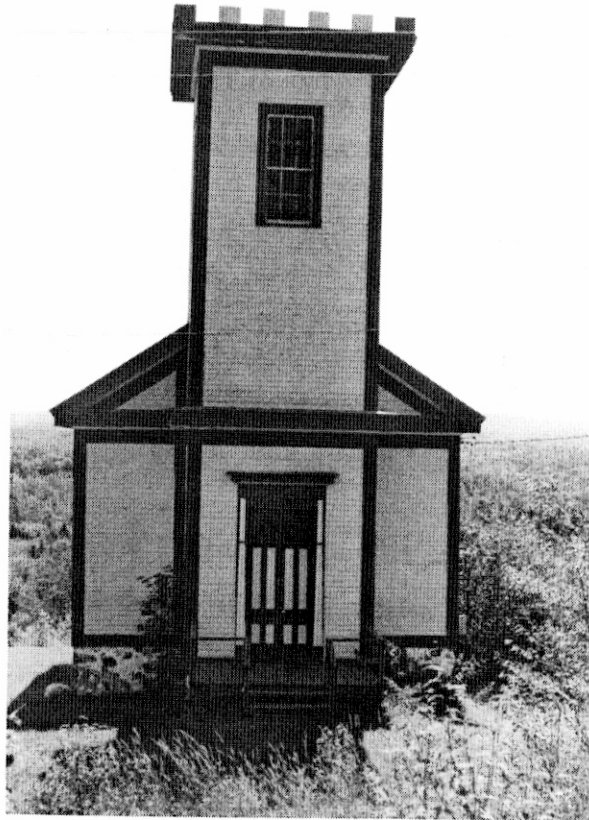
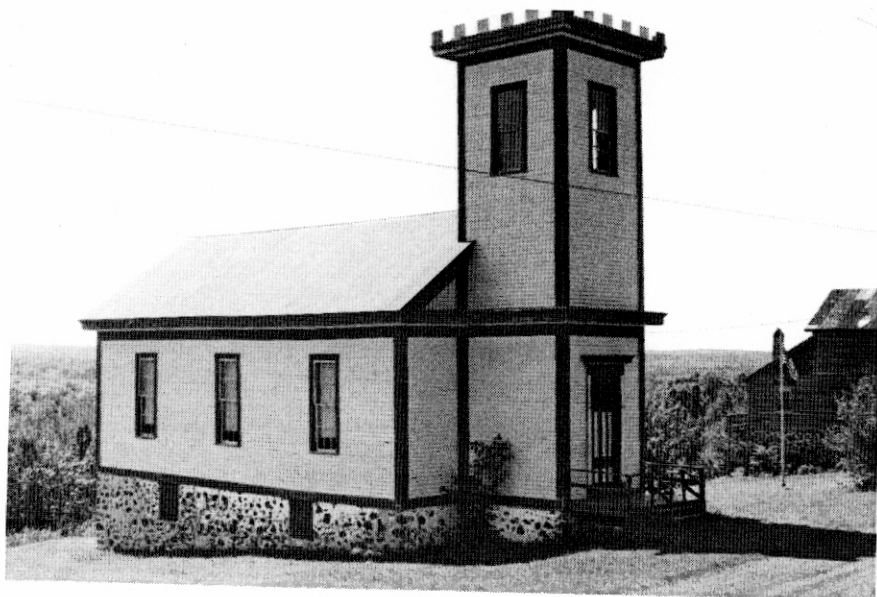
Fig. 1 Exterior views of church. Photos by author, 1975.

1. Architectural character: The Central Mine Methodist Episcopal Church is an extremely simple, rectangular frame building with a bell tower. It is typical of the small Protestant churches built in the nineteenth century by immigrant groups in the Copper Country. Yet the battlements on the bell tower, the buff and crimson exterior color scheme, and the interior grained woodwork make the church unique in the region (fig. 1).
2. Condition of fabric: Good.

1. Overall dimensions: The church is rectangular in plan and measures about 26 ½ x 45 ½ feet; the attached bell tower has a ten-foot square footprint. While the church itself has a three-bay wide façade, this is hidden from view by the one bay bell tower façade and entrance. The church is one-story in height and the bell tower rises to two-stories in height.

2. Foundations: Stone walls about 30" thick.
3. Walls: The church and tower are covered with buff-painted clapboards. The corners are accentuated by red-painted, vertical corner boards, and a flat board also painted red makes up the watertable.
